# Manhole Inspection Summary

Manhole # S17M\_\_013MH

Insp Date: **5/7/09 9:55 AM**

**Location** Address: **2502 DULANY ST**

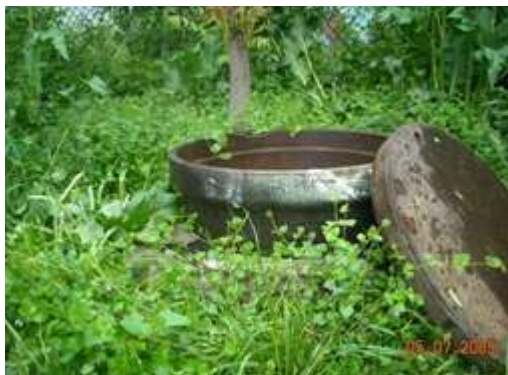
Msicellaneous

Comments **CLEARED BRUSH FROM AROUND MANHOLE; CLEANED FROM DOWNSTREAM MANHOLE S17M\_\_012MH FOR 1 HOUR - 2 PASSES, UNABLE TO LOCATE DOWNSTREAM MANHOLE S17M\_\_024MH; STRUCTURE IS ON GRADE WITH FRAME ABOVE.**

FRAME ABOVE GRADE

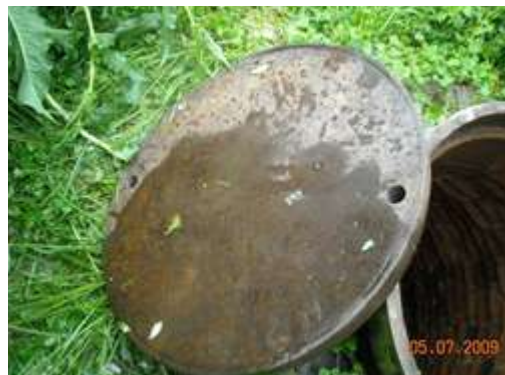
Miscellaneous

Type: **Sanitary** Condition: **Worn** Cover Material: **Cast Iron**

WORN COVER

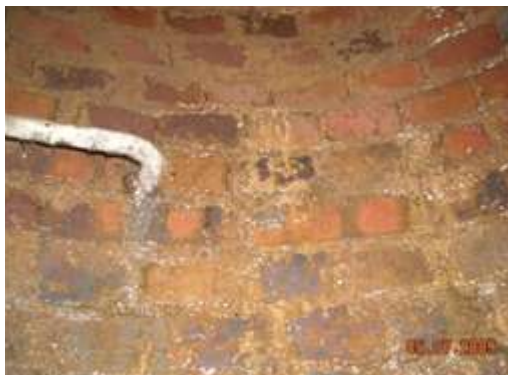
Defect 6

Infiltration: ☐ None ☐ Joint ☐ Cracks ☐ Mortar ☐ Roots ☒ **Wall**

INFILTRATION @ CORBEL WALL

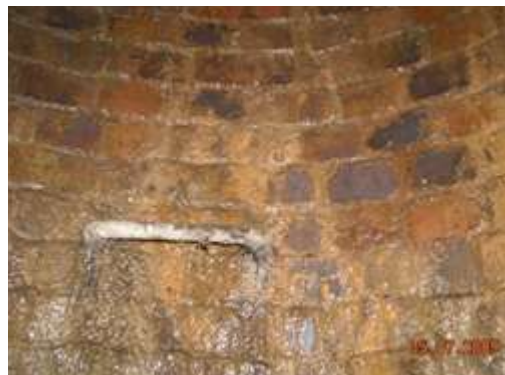
Defect 5

Infiltration: ☐ None ☐ Joint ☐ Cracks ☐ Mortar ☐ Roots ☒ **Wall**

INFILTRATION @ BARREL WALL

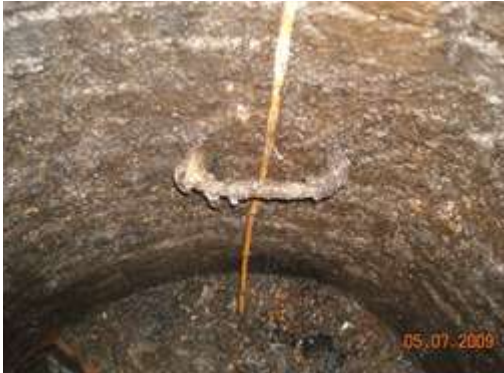
Defect 4

**Surcharge** ☒ **Evidence Of Surcharge** Depth: **5** (ft.) ☐ Active Surcharge Present

SURCHARGE EVIDENCE ON BOTTOM  
3 STEPS

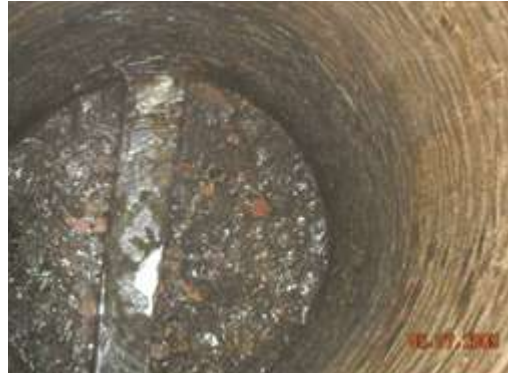
Defect 3

Condition: ☐ Sound ☐ Cracked ☐ Root Intrusion ☐ Deteriorated ☐ Leaks ☒ **Debris**

DEBRIS ON BENCH & CHANNEL

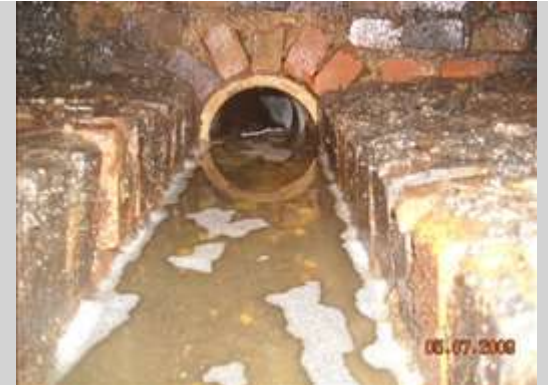
12 O'Clock Outflow

8 in. Circular Gravity Sewer  
Pipe Out @ 12 O'Clock

Pipe Height: **8.4** (in.) Rod and Bar (Angled)  
Pipe Material: **Clay** ☐ Pipe Lined  
Invert Depth: **17.39** (ft.) Flow Characteristics: **Slow**  
Deposits: ☒ None ☐ Mud ☐ Sludge ☐ Debris ☐ Grease  
Silt Depth: **0** (in.) Deposits Extent:  
Infiltration: **None** Pipe Seal Cond: **Sound**

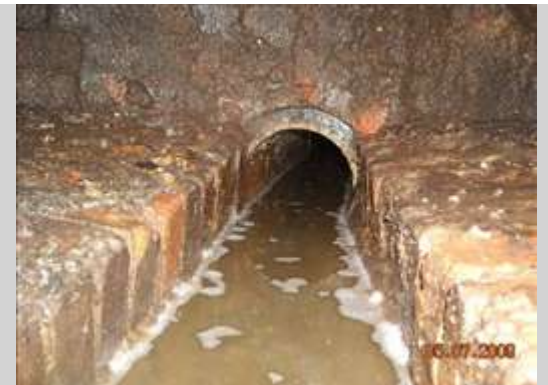
6 O'Clock Inflow

8 in. Circular Gravity Sewer  
Pipe In @ 6 O'Clock

Pipe Height: **8.4** (in.) Rod and Bar (Angled)  
Pipe Material: **Clay** ☐ Pipe Lined  
Invert Depth: **17.20** (ft.) Flow Characteristics: **Slow**  
Deposits: ☒ None ☐ Mud ☐ Sludge ☐ Debris ☐ Grease  
Silt Depth: **0** (in.) Deposits Extent:  
Infiltration: **None** Pipe Seal Cond: **Sound**
